Re: NWC Preliminary Historic Resource Treatment Recommendations

INTRODUCTION

HISTORIC RESOURCES ANALYSIS AND RECOMMENDATIONS

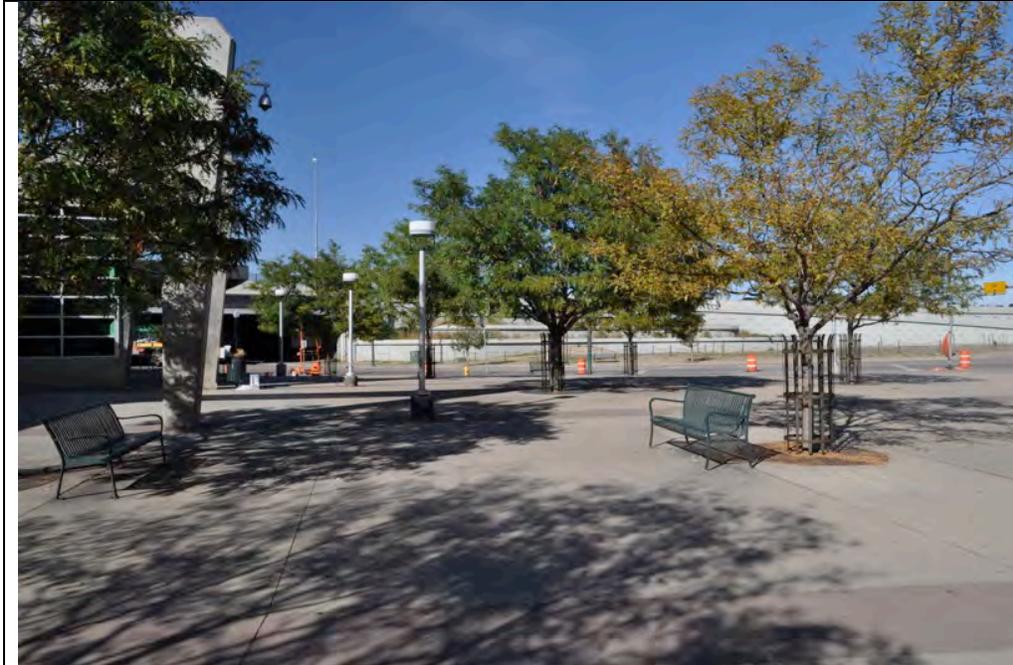
A view looking north, across the plaza in front of the Coliseum

Condition: The Arena and Arcade are in good condition; however the Horse Barn has significant structural deficiencies and has been recommended for demolition in prior studies.

Potential uses: The building is in good condition. The Coliseum offers reuse opportunities for event space, such as tournaments and concerts. Other possible uses could include agriculture related business either supporting NWC or as a stand-alone headquarters for a larger corporate user.

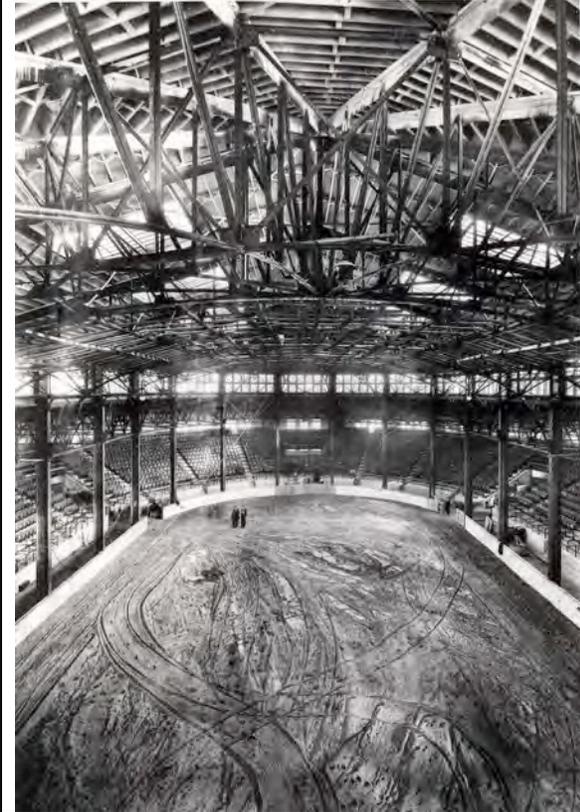
Interior of the Stadium Arena -1908
Exposed steel trusses, skylights and a 360° clerestory.

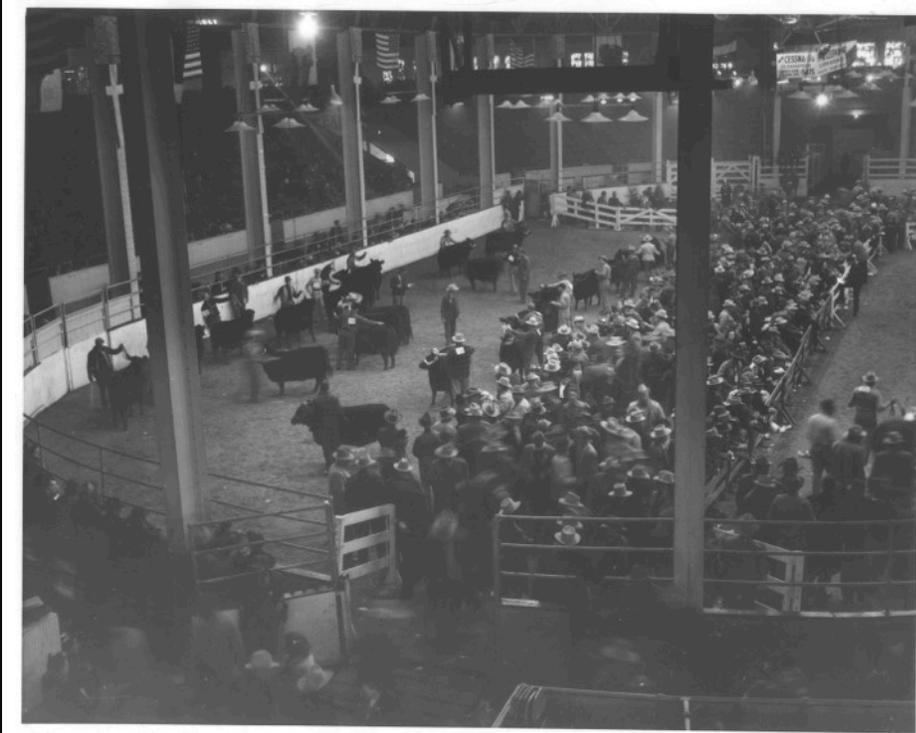
Interior of the Stadium Arena during a cattle-judging event – 1948.

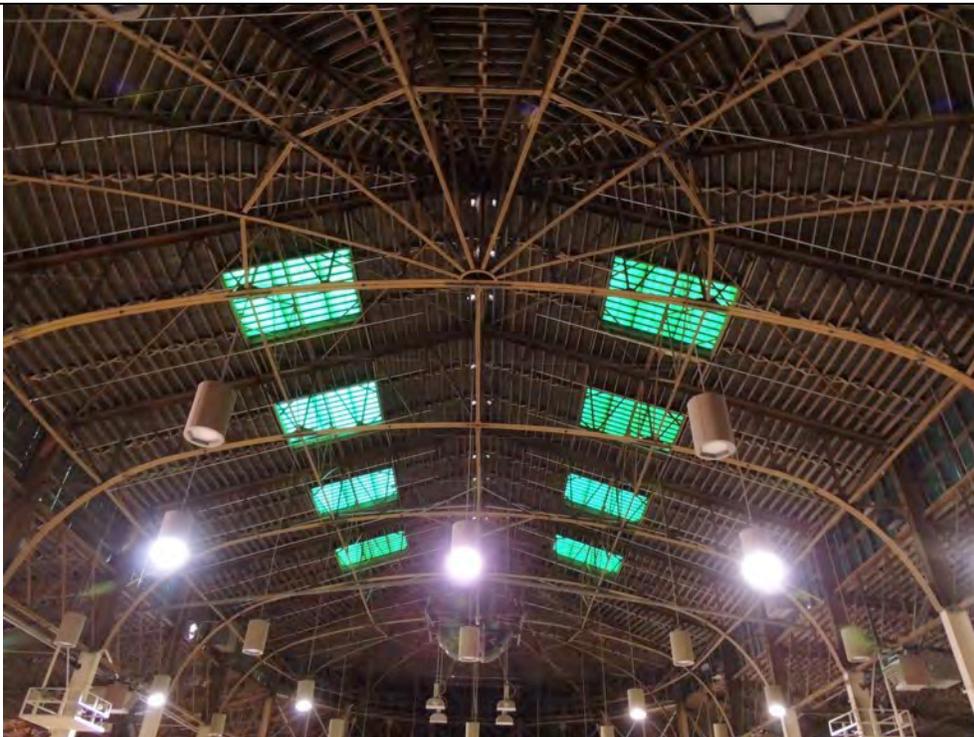
Steel roof trusses and skylights. Clerestory is covered, 2016.

Condition: This building is in good condition and is largely intact. A grant has been applied for by WSSA through History Colorado for a full roof replacement of this facility.

Treatment suggestions: The priority is to restore in place. This includes retaining the interior lofted space and seating areas (to be further considered in the ongoing HSA). Considering using some of the later additions as back of house space may help support the main building. Alternative uses that showcase Western Heritage and food production are also appropriate. It is also recommended to remove the paint after testing and restore the brick exterior.

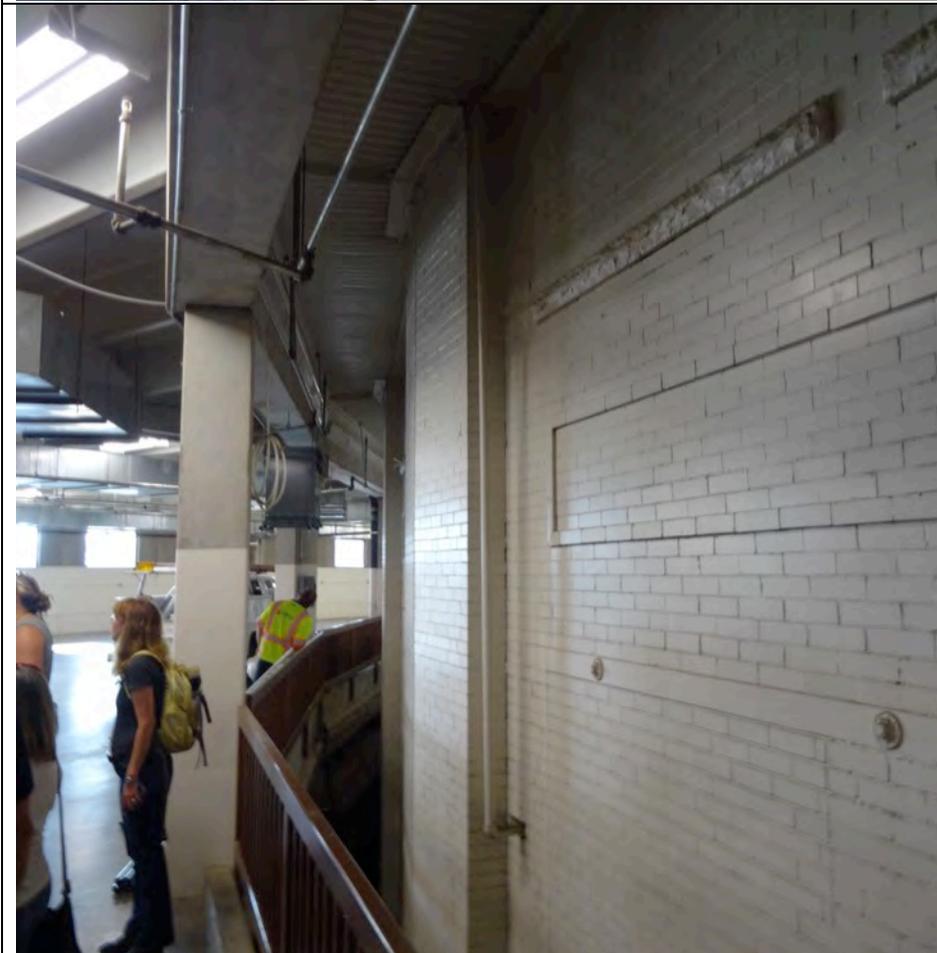
The space between the original building and the Stadium Hall addition, 2017.

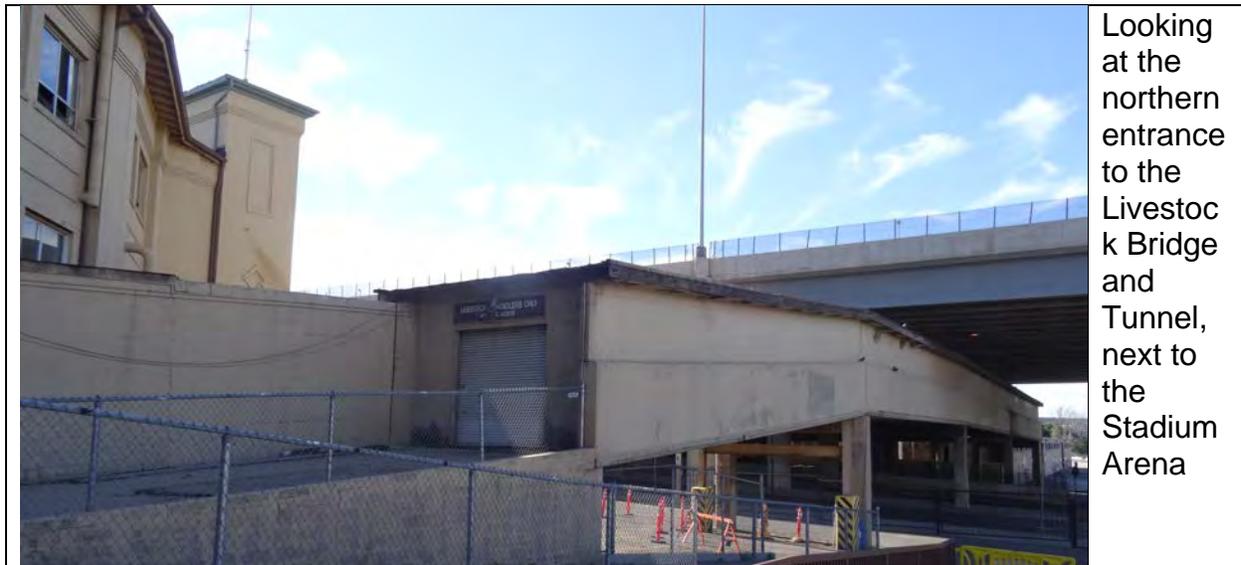
Looking at the northern entrance to the Livestock Bridge and Tunnel, next to the Stadium Arena

Condition: The Livestock Bridge and Flyover is in poor condition, and is unusable due to safety concerns.

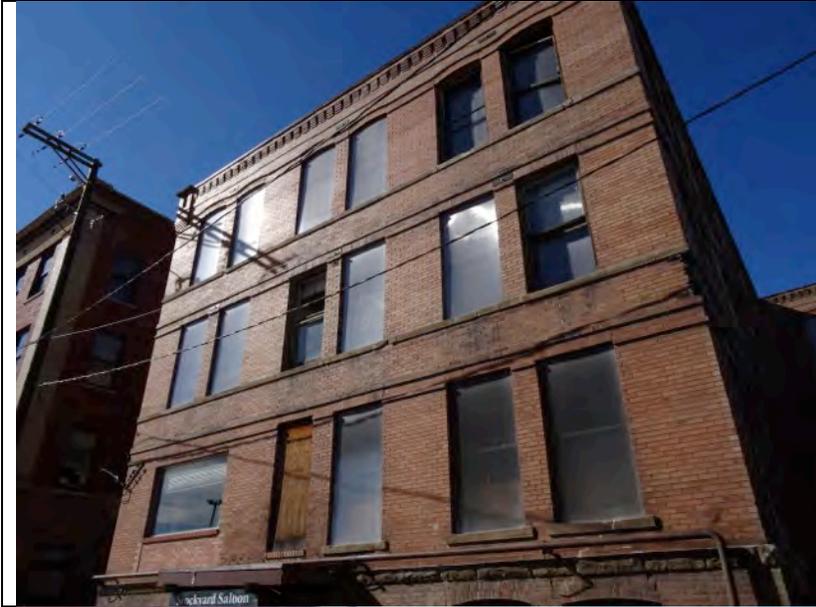
Building A. 1898
Northeast elevation.

Condition: Building A. 1898 exterior: This building has some degree of fire damage. The exterior appears to be in fair condition. There are some enlarged and partially blocked window openings and patched masonry. 1898 interior: Unable to access interior due to significant fire damage and exposed asbestos contamination.

- Further investigation is recommended to determine the condition of the interior and the potential for rehabilitation, especially given its importance to the history of the site.
- If reuse proves to be feasible, consider the potential for this building to provide supporting spaces for the front (1916) building.
- If adaptive reuse is not feasible, document the structure before demolition.
- Include material from the documentation of the structure in interpretive materials.

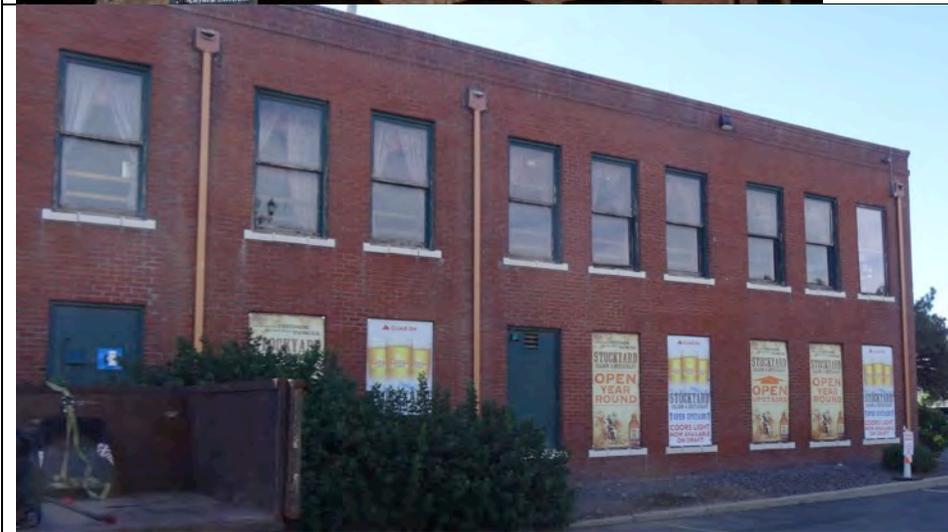
Building C.
1919
Southwest elevation.

Building C. 1919: This building appears to be in good condition. It currently houses a restaurant on the second floor. The first floor was not inspected. The exterior remains relatively intact, although lower level windows are covered with plywood, so their condition is unknown. Nonetheless, the building has potential for adaptive reuse, especially in combination with the other two Livestock Exchange Buildings.

- Further investigation is recommended to determine the condition of the first floor interior.
- Consider the potential for adaptive reuse of this building to provide supporting spaces for the front (1916) building.
- If adaptive reuse is not feasible, document the structure before demolition.
- Include information from the documentation of the structure in interpretive materials.
- Consider the opportunity to reuse a large safe that is located on the second floor as an interpretive feature.

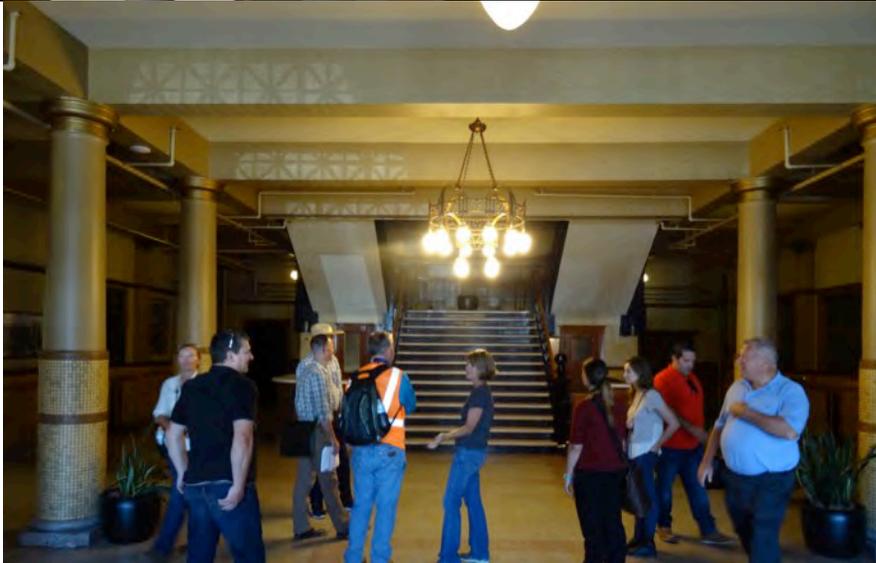
Building B. 1916 Grand
foyer and staircase
with large columns and
chandelier.

Building B. 1916: This building appears to be in good condition.

- Preservation and adaptive reuse is preferred.
- A more detailed analysis is recommended to study the potential for specific use options.

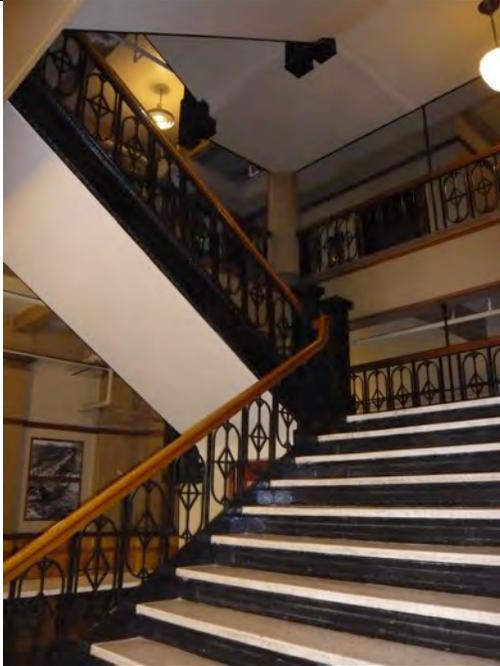
Building B. 1916 Grand
staircase detail of cast
iron balustrade and
piers, and wood rail.

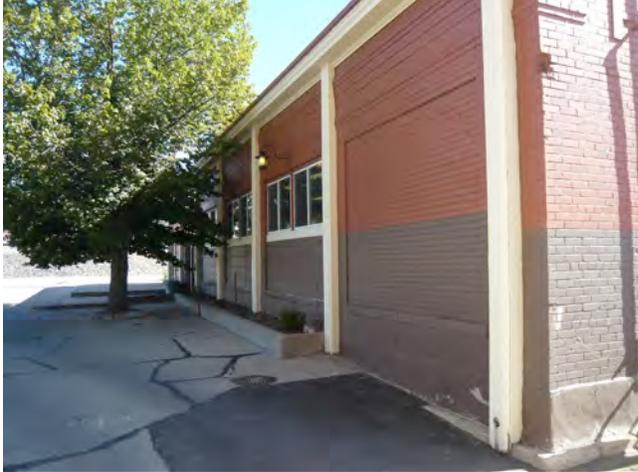
<p>Northeast elevation (location of former garage doors).</p>

Condition: The exterior appears to be in good condition.

Potential uses: If feasible, the rehabilitation of this building could include removing coverings and reopening window and garage openings. Metal glazed garage doors could be installed that reflect the historic door framing. An assessment of the interior is recommended if the potential to preserve in place would be consistent with the Master Plan. A variety of adaptive reuse opportunities to consider could include:

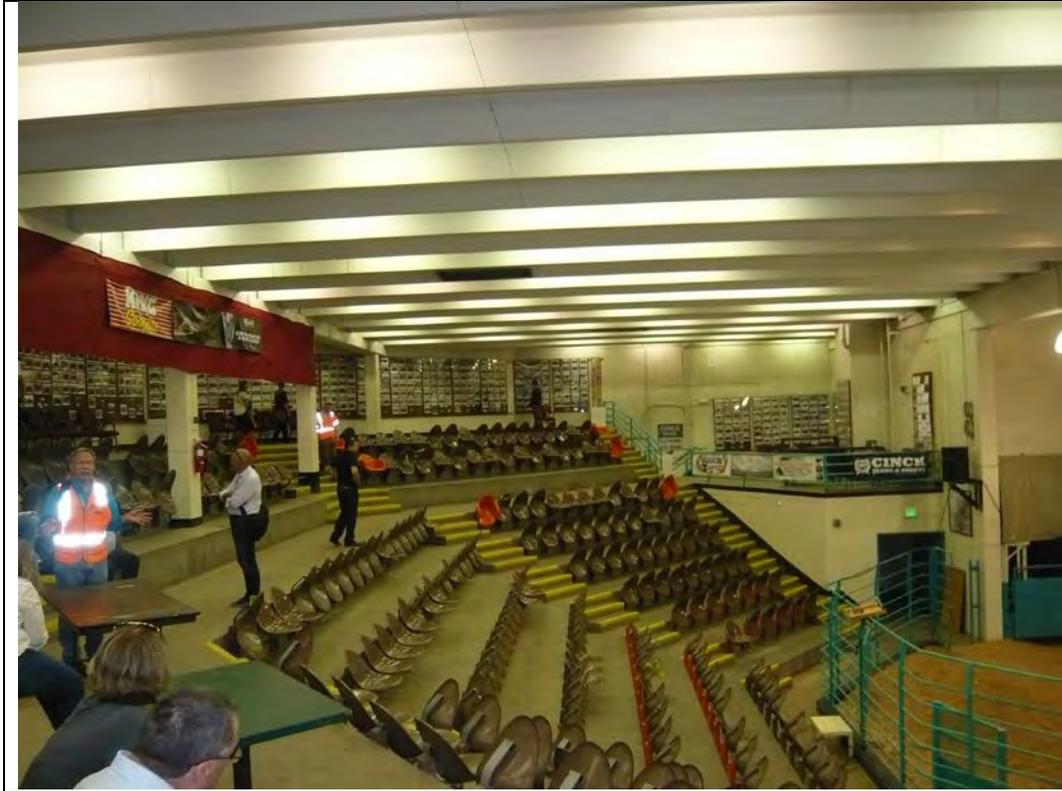
View of the interior.

Condition: The property appears to be in good condition.

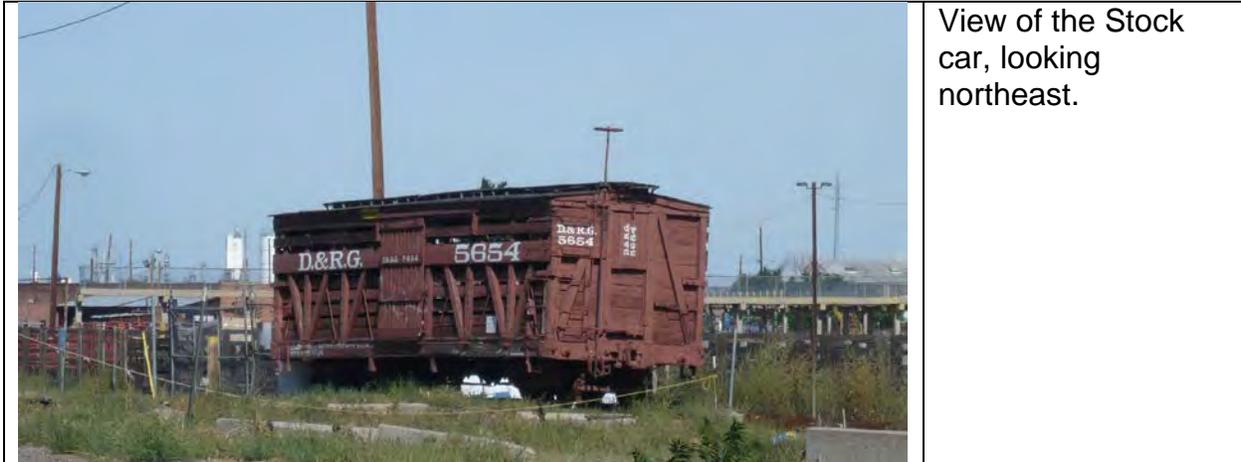
View of the Stock car, looking northeast.

Condition: The car appears to be in fair condition.

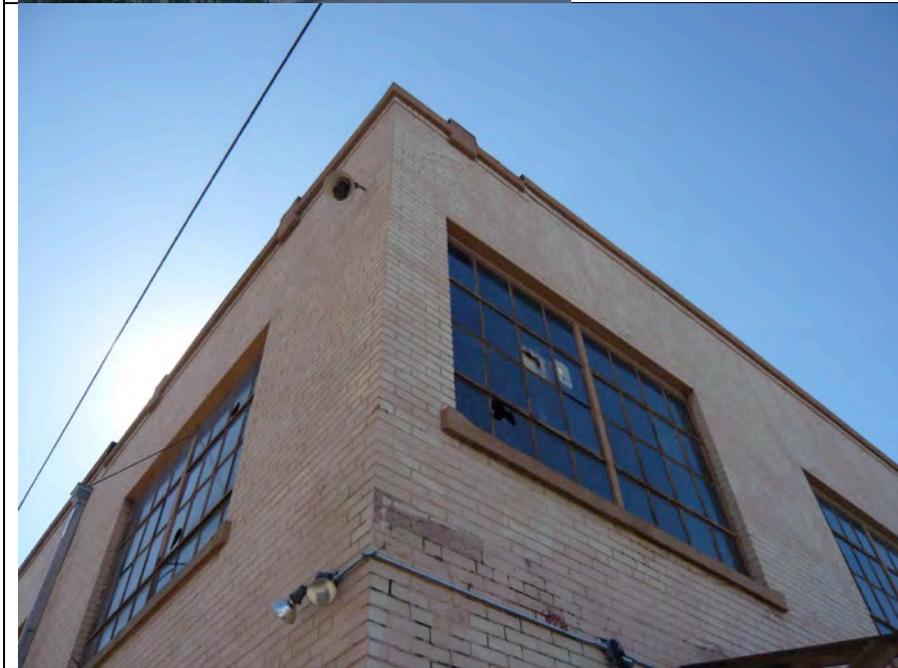
Detail of steel warehouse windows. Some ganged glazing panels are operable awnings.

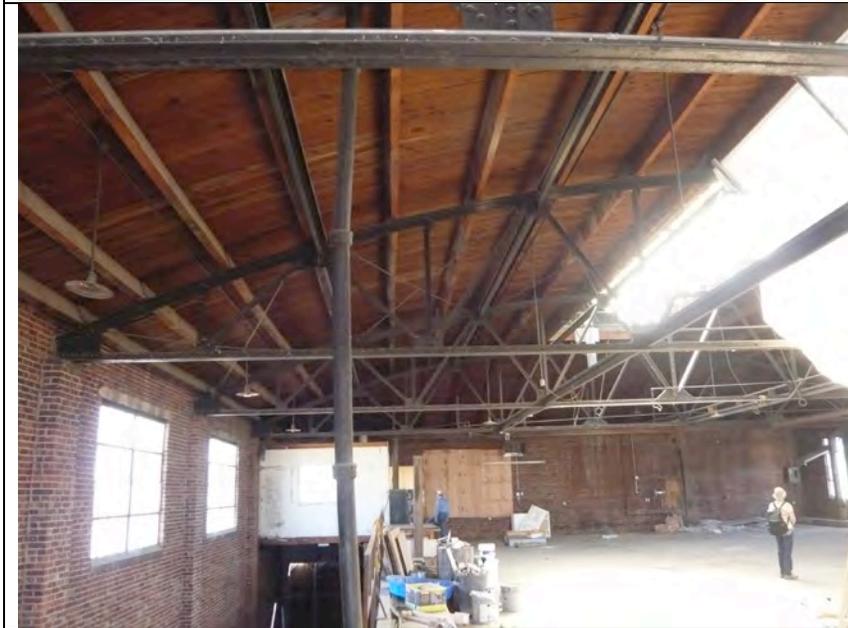
The upper floor of the interior is lofted providing a dramatic clear span. The space is crowned with exposed bowed steel trusses and an operable clerestory that lights and ventilates the space.

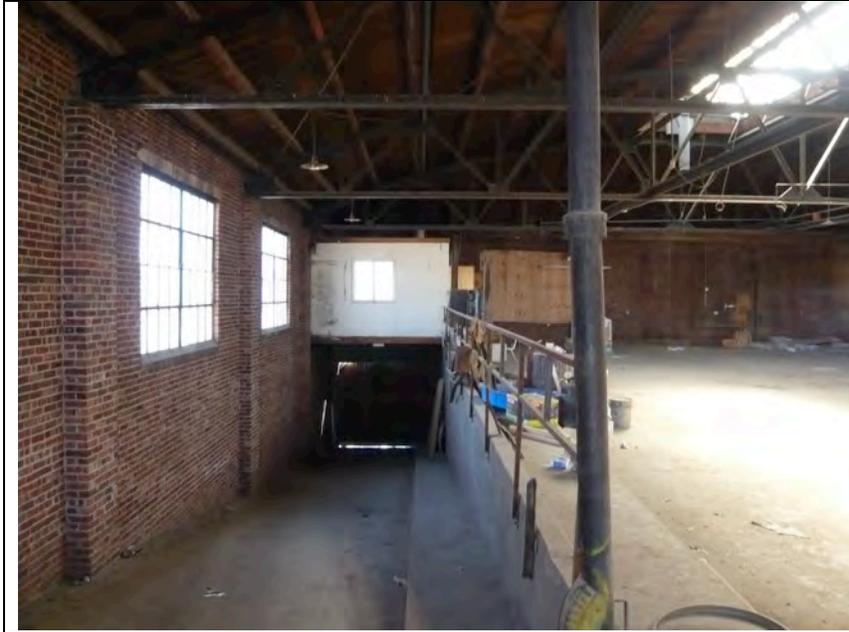
View of pedestrian/auto ramp to upper level loft space. The wall along the drive could be a perfect wall to display interpretive features and artifacts.

Condition: This building appears to be in fair condition.

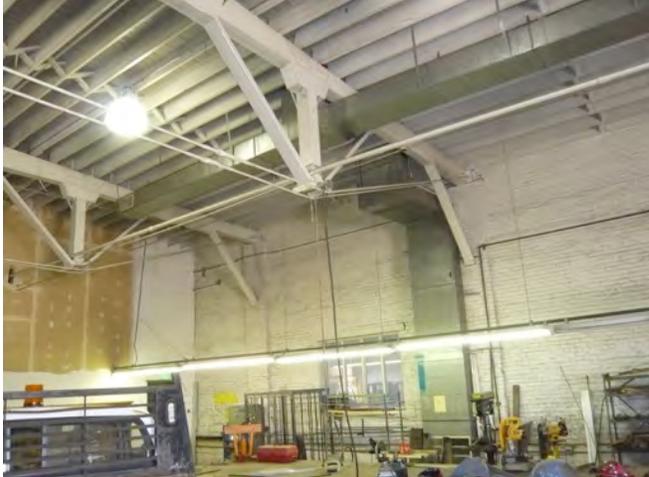
<p>Interior with clear span truss system</p>
---	--

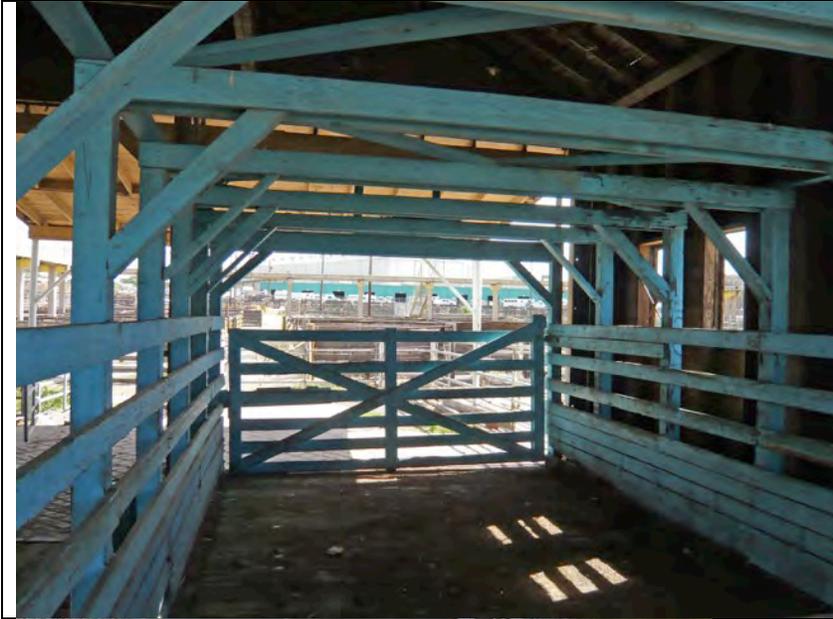
Open wood frame ceiling at holding pen

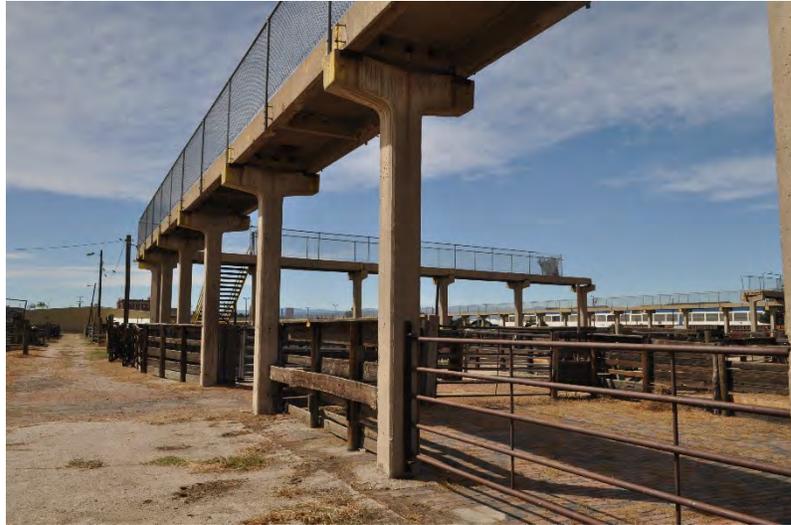
Brief description: Concrete columns and platform, metal stairs and chain-link fence comprise the catwalks. They have 20-24-foot tall t-shaped columns that are 1'x1' in diameter and 5' wide at the top (t-shaped top extension). The concrete contains remnants of yellow paint. The walk is fenced with a 4-foot tall chain-link fence. Metal grated stairs provide access at certain points. Some catwalk segments have been repaired and others have collapsed.

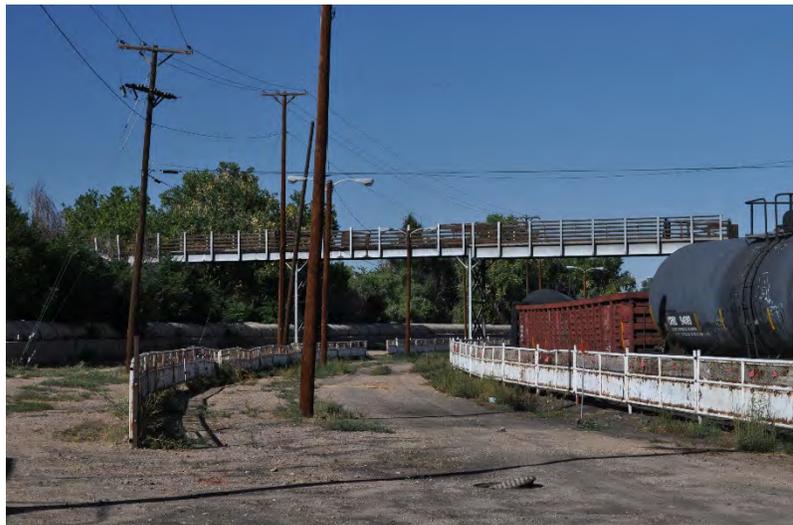
concrete base support five approximately 80-foot steel spans. The 9-foot wide deck consists of three concrete approach spans on the east side and wood decking extending to the western end of the structure. A railing lines the entire bridge (including inside the two pony truss spans), with steel railings bolted to the deck. Six slats of wood are attached to the posts.
